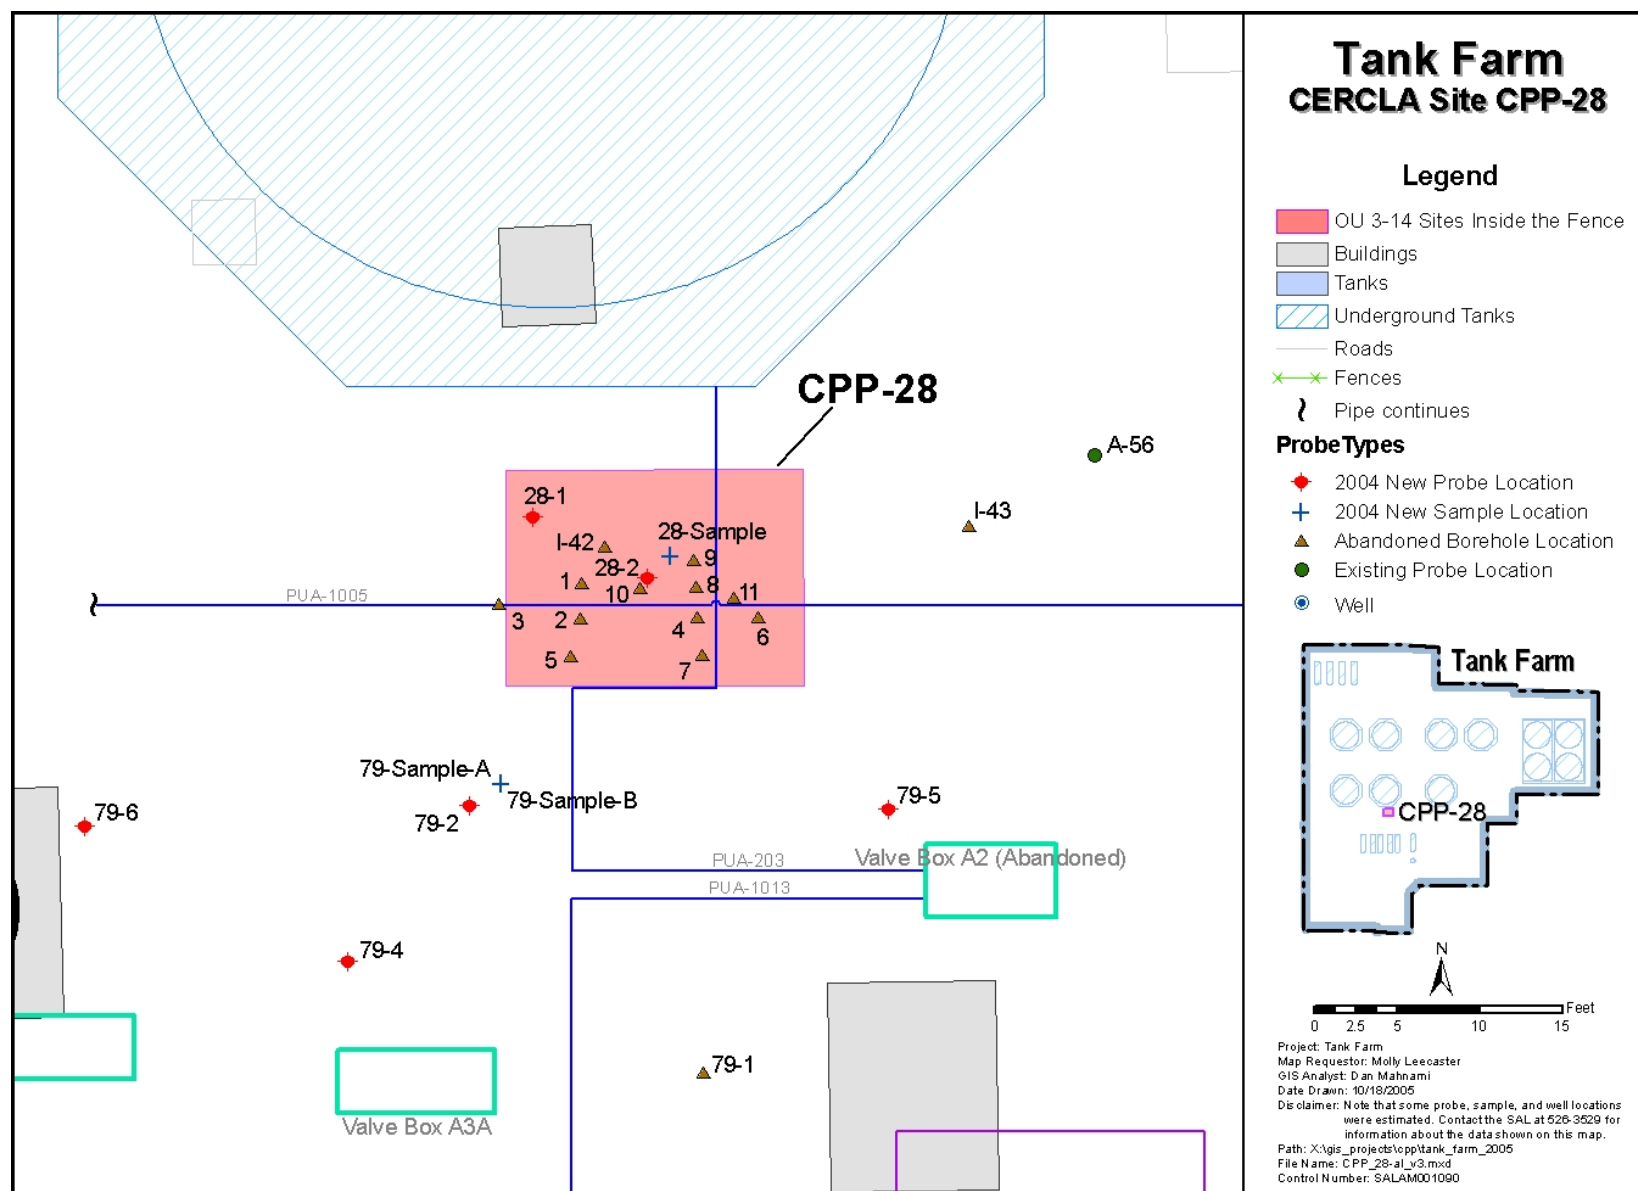
Figure 5-20. CPP-28 detailed map.

Trenching operations were started on October 22, 1974, beginning at the intersection of an underground electrical duct near Junction Box No. 3, approximately 25 ft west of Anode 1-42, and working eastward directly above Line 3"PUA-1005 (Figure 5-20). A lap joint in the encasement was uncovered and inspected approximately 10 ft west of Anode 1-42. This inspection revealed a 1.5-in. separation at the lap joint and a longitudinal joint separation of several feet where the tapping screws had corroded. The inside of the encasement in the region of joint separation was partially filled with soil. At that point in the investigation, several holes were hand-augered to depths of 3 ft below the encasement with no indication of soil contamination.

Contaminated soil was first encountered during the trenching operations approximately 3 ft west of Anode 1-42. This soil was believed to have been brought up during the augering of the exploratory test holes. Trenching continued eastward approximately 10 ft past the zone of contamination. A second encasement lap joint was encountered approximately due south of Anode 1-42. Inspection of the joint revealed a greater degree of deterioration than with the first joint uncovered. A section of the upper carbon-steel cover approximately 1 ft long appeared to be severely corroded (presumably from contact with an acidic waste solution) and had some inward collapse.

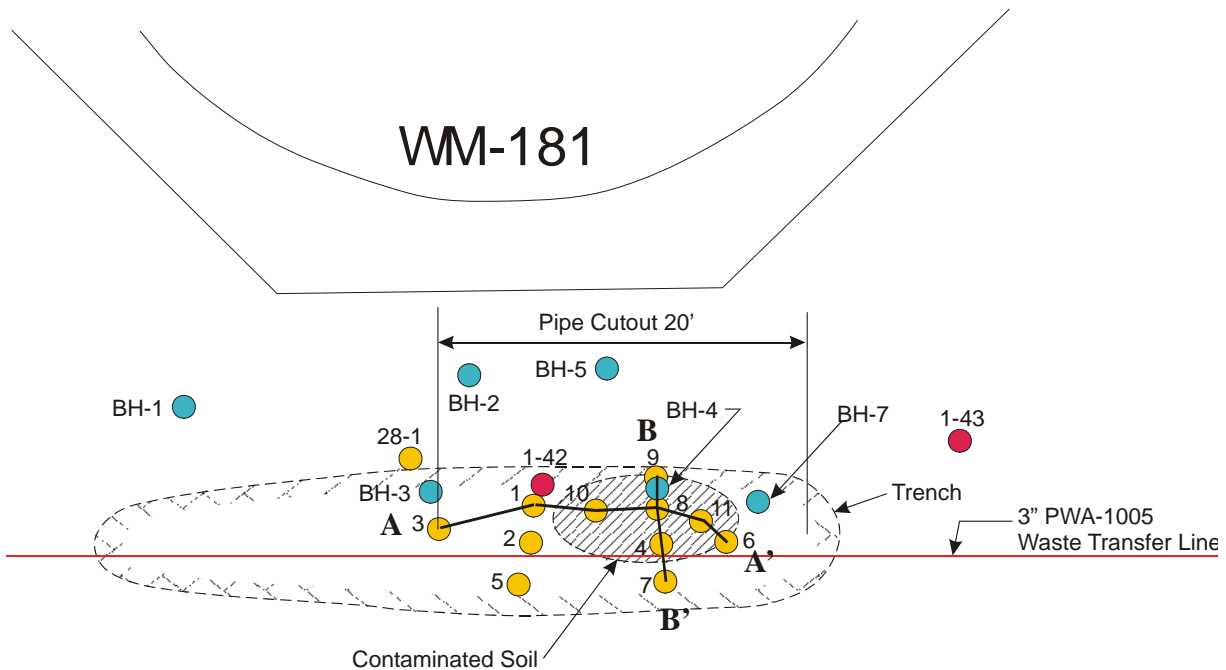
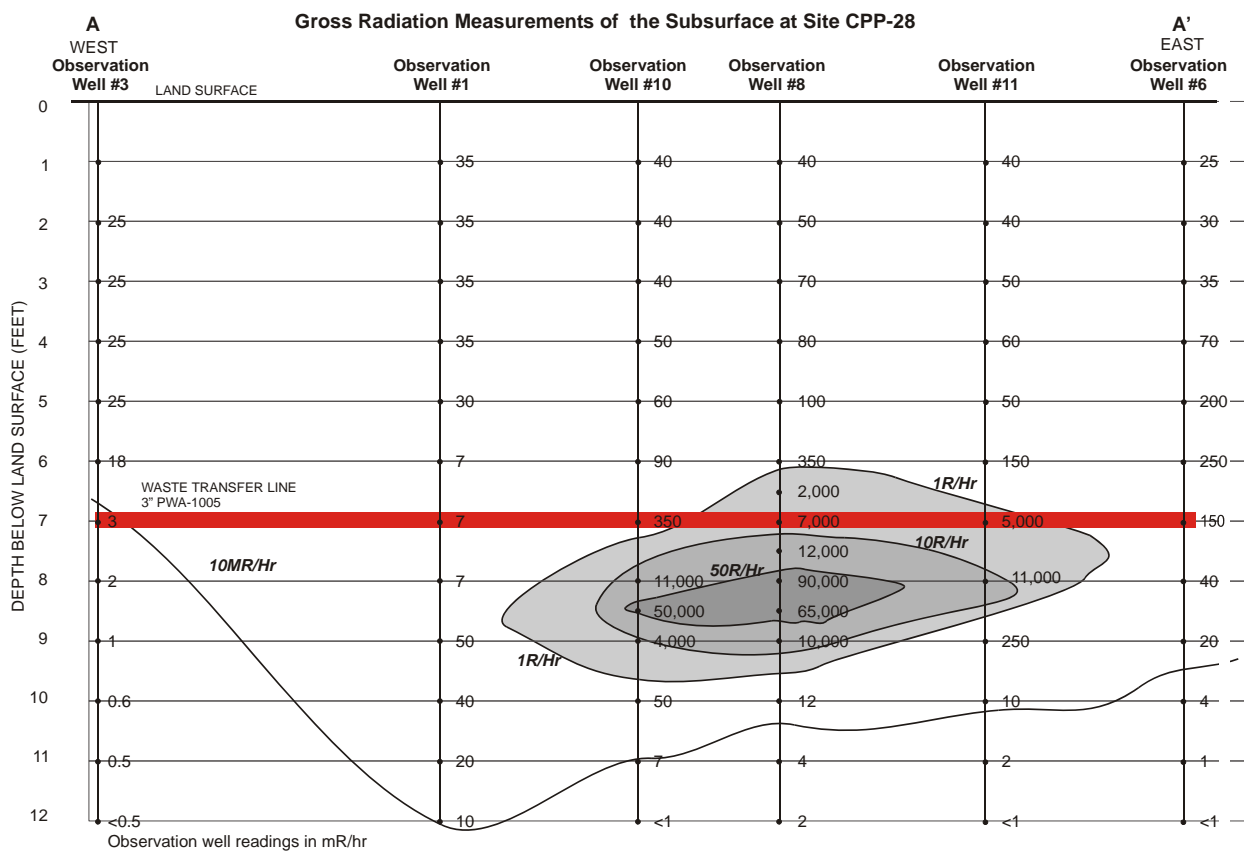
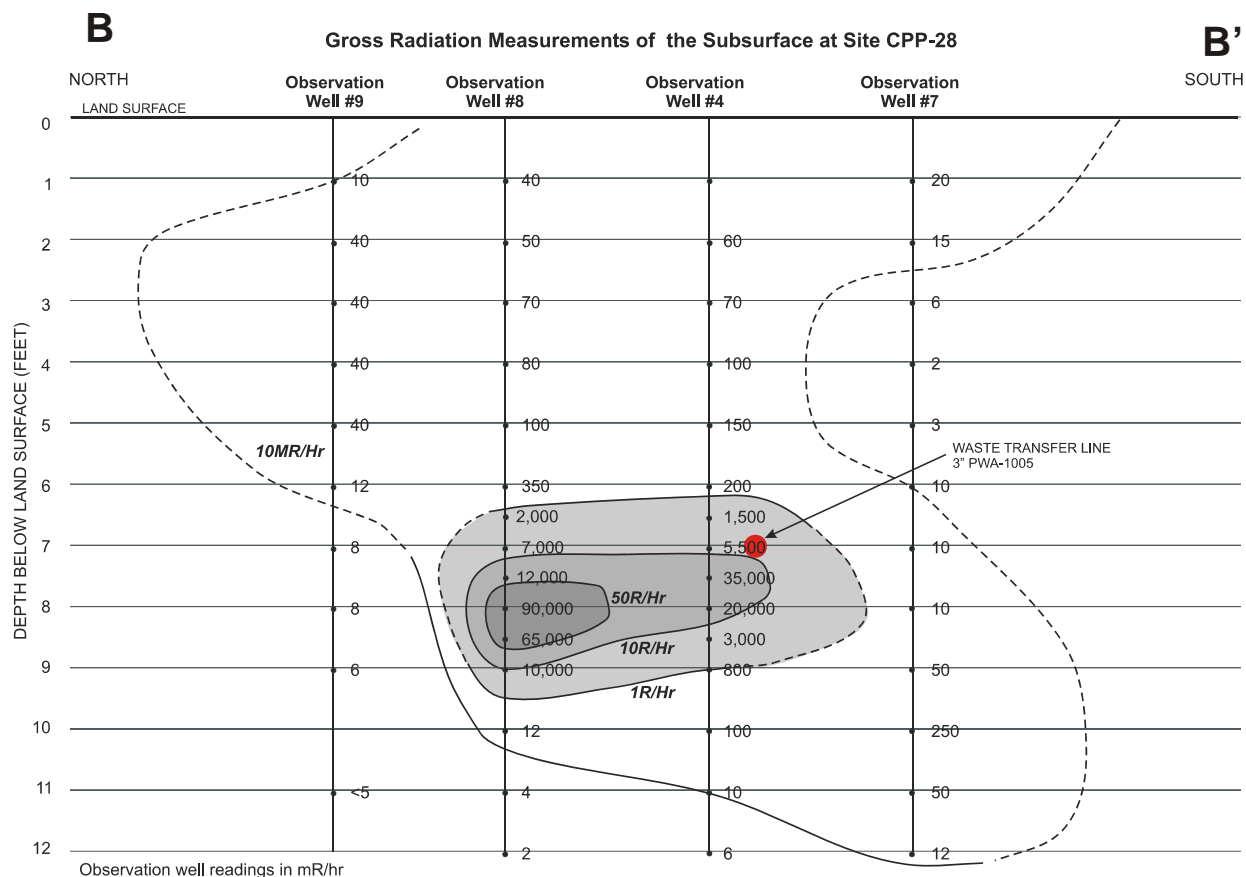
From the data provided by the 11 test pipes, the zone of soil contamination was estimated to be approximately 9 ft in diameter by 2 to 3 ft in average depth below the pipe encasement at a depth of 7 ft bgs (Figures 5-23, 5-24, and 5-25). As described previously, calculations made during the investigation estimated that approximately 128 ft<sup>3</sup> of contaminated soil existed at the site and the amount of contamination remaining was around 3,000 Ci.

**5.9.5.3 Areal Extent.** The areal extent of contamination appears to be conservatively defined by the original release investigation, as depicted in Figures 5-24 and 5-25.

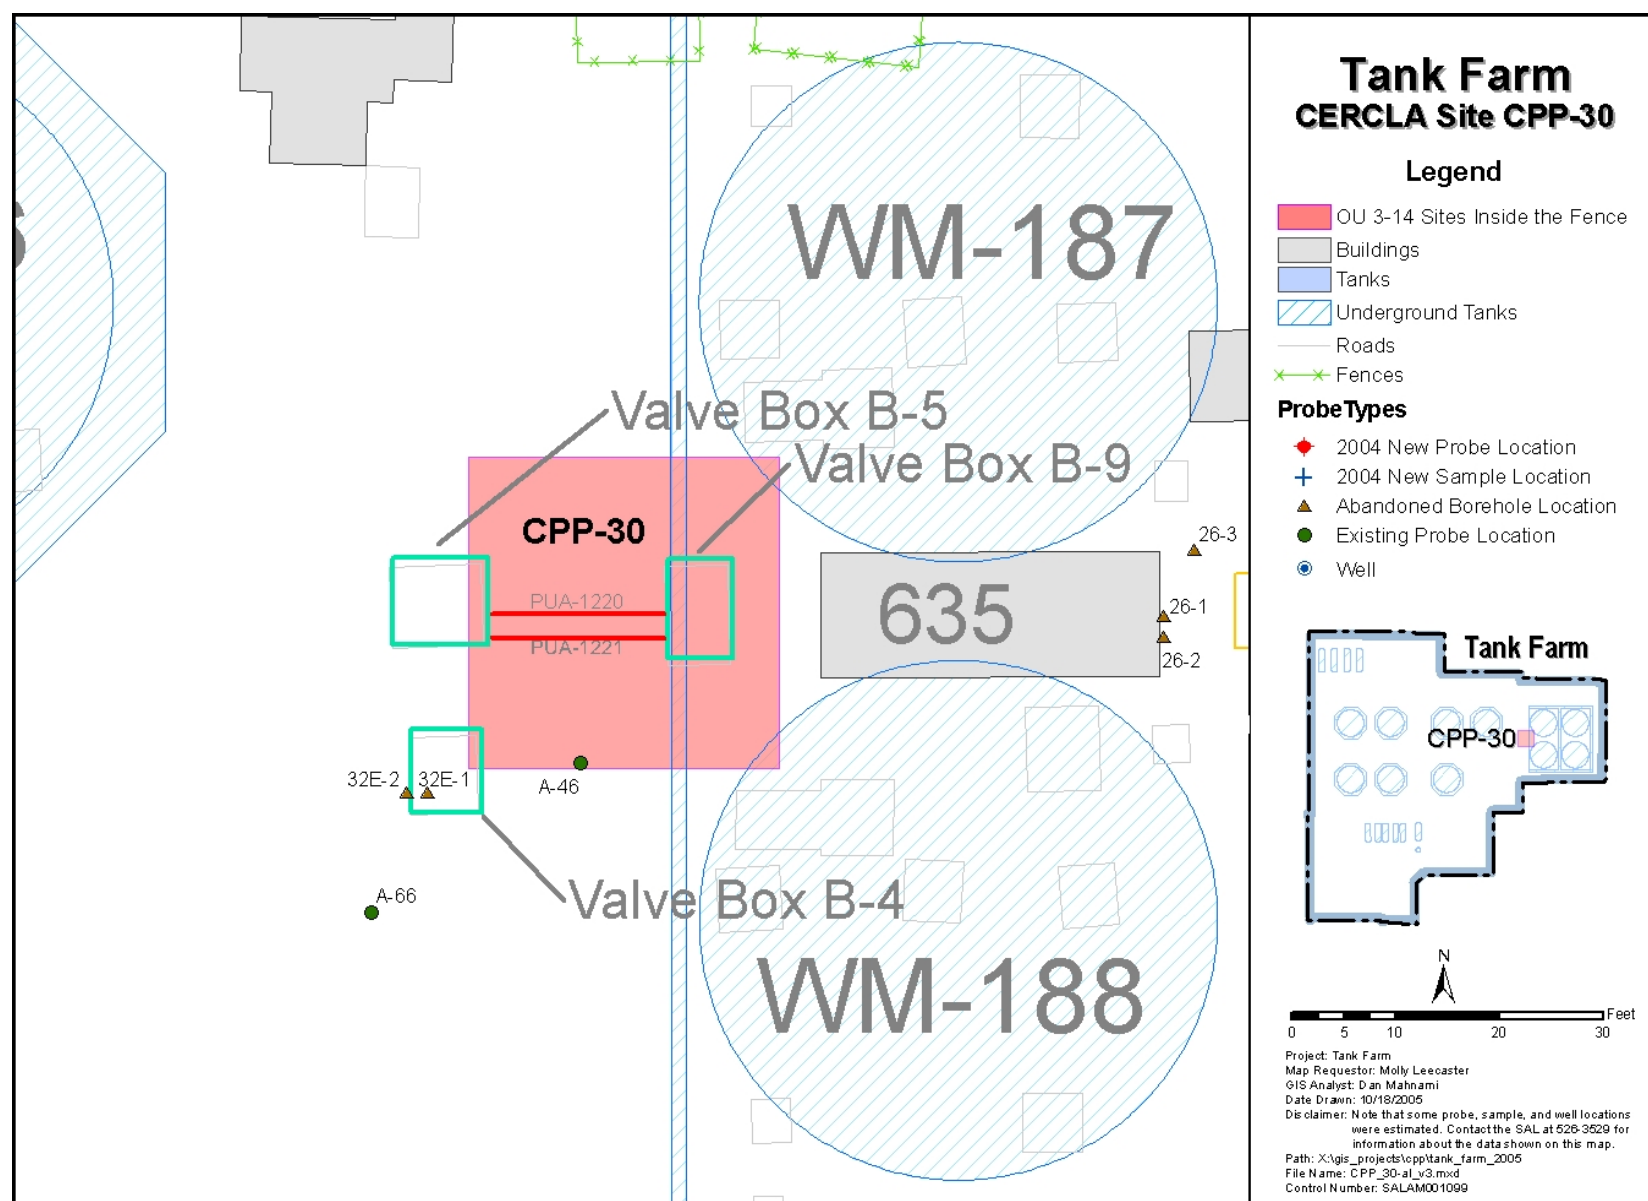
Figure 5-26. Detailed map of CPP-30.

Site CPP-30 was contaminated on June 2, 1975, during activities associated with valve maintenance inside Valve Boxes B-5 and B-9 (Figure 5-26). The contamination was the result of poor housekeeping during equipment maintenance activities, not the failure of any installed waste handling equipment. A Significant Operating Occurrence Report (Linhart 1975) describes the events associated with the contamination incident

When the contaminated valve parts were removed from the valve boxes, residue from the valves, tools, or workers (the workers and their clothing were contaminated) contaminated the soil around the two valve boxes. The area around the valve boxes had been covered with blotter paper to prevent soil contamination. However, the Occurrence Report indicates the blotter paper was torn in places where it had rested on the rocky tank farm surface and had been walked upon by personnel. In addition, the blotter paper coverage may have had gaps that allowed soil contamination to occur. The Occurrence Report recommended future tank farm work cover the lip of the concrete valve box with blotter paper, implying such coverage may not have existed with this particular job. Thus, although attempts were made to prevent soil contamination, the efforts were not completely successful.

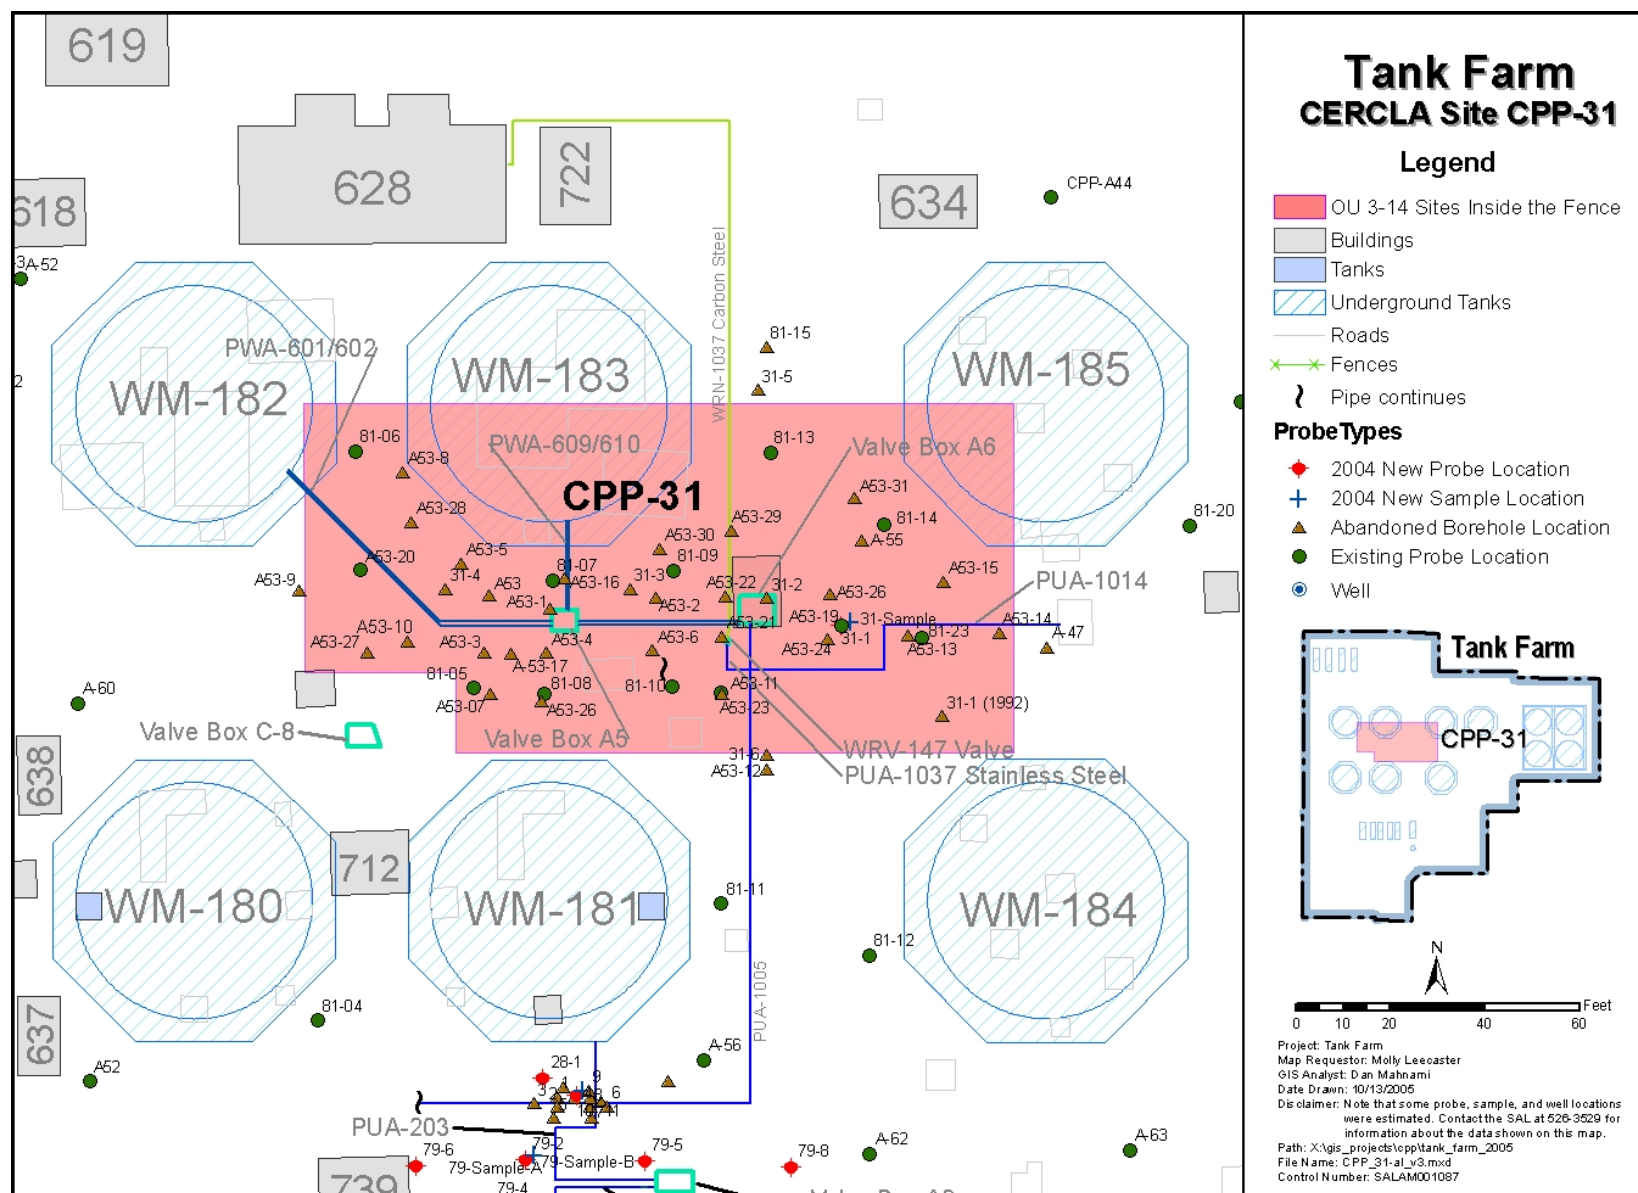
Figure 5-28. CPP-31 release site boundary and locations of monitoring wells and soil probes in and around the release site.

In September 1975, 10 additional monitoring wells (A-50 through A-59) (Figure 5-28) were drilled and installed to extend the monitoring network to the older part of the tank farm. On September 18, 1975, while drilling monitoring well A-53, located approximately 15 ft southwest of Tank WM-183 and 10 ft south of the edge of the tank vault (Figure 5-28), contaminated soil was brought to the surface. Beta/gamma radiation levels in the auger drill cuttings reportedly ranged from 100 mR/hr at 15 ft bgs to 500 mR/hr at 22 ft bgs. A radiation profile was taken by lowering a radiation detector into the hollow-stem augers. Readings greater than 10 R/hr were measured at depths of 14, 18, 19, and 23 ft below grade. Well A-55, located southwest of WM-185, also encountered contaminated soil but at lower concentrations than A-53.

**5.11.5.3 Areal Extent.** As indicated in Figure 5-28, the areal extent of contamination at CPP-31 extends at least 125 ft east-west and about 30 ft north-south and appears to have migrated along the concrete enclosure housing waste transfer lines PWA-601/602 connecting Valve Boxes A-5 and A-6 to WM-182 and waste transfer lines PWA-609/610 buried about 11-12 ft bgs.

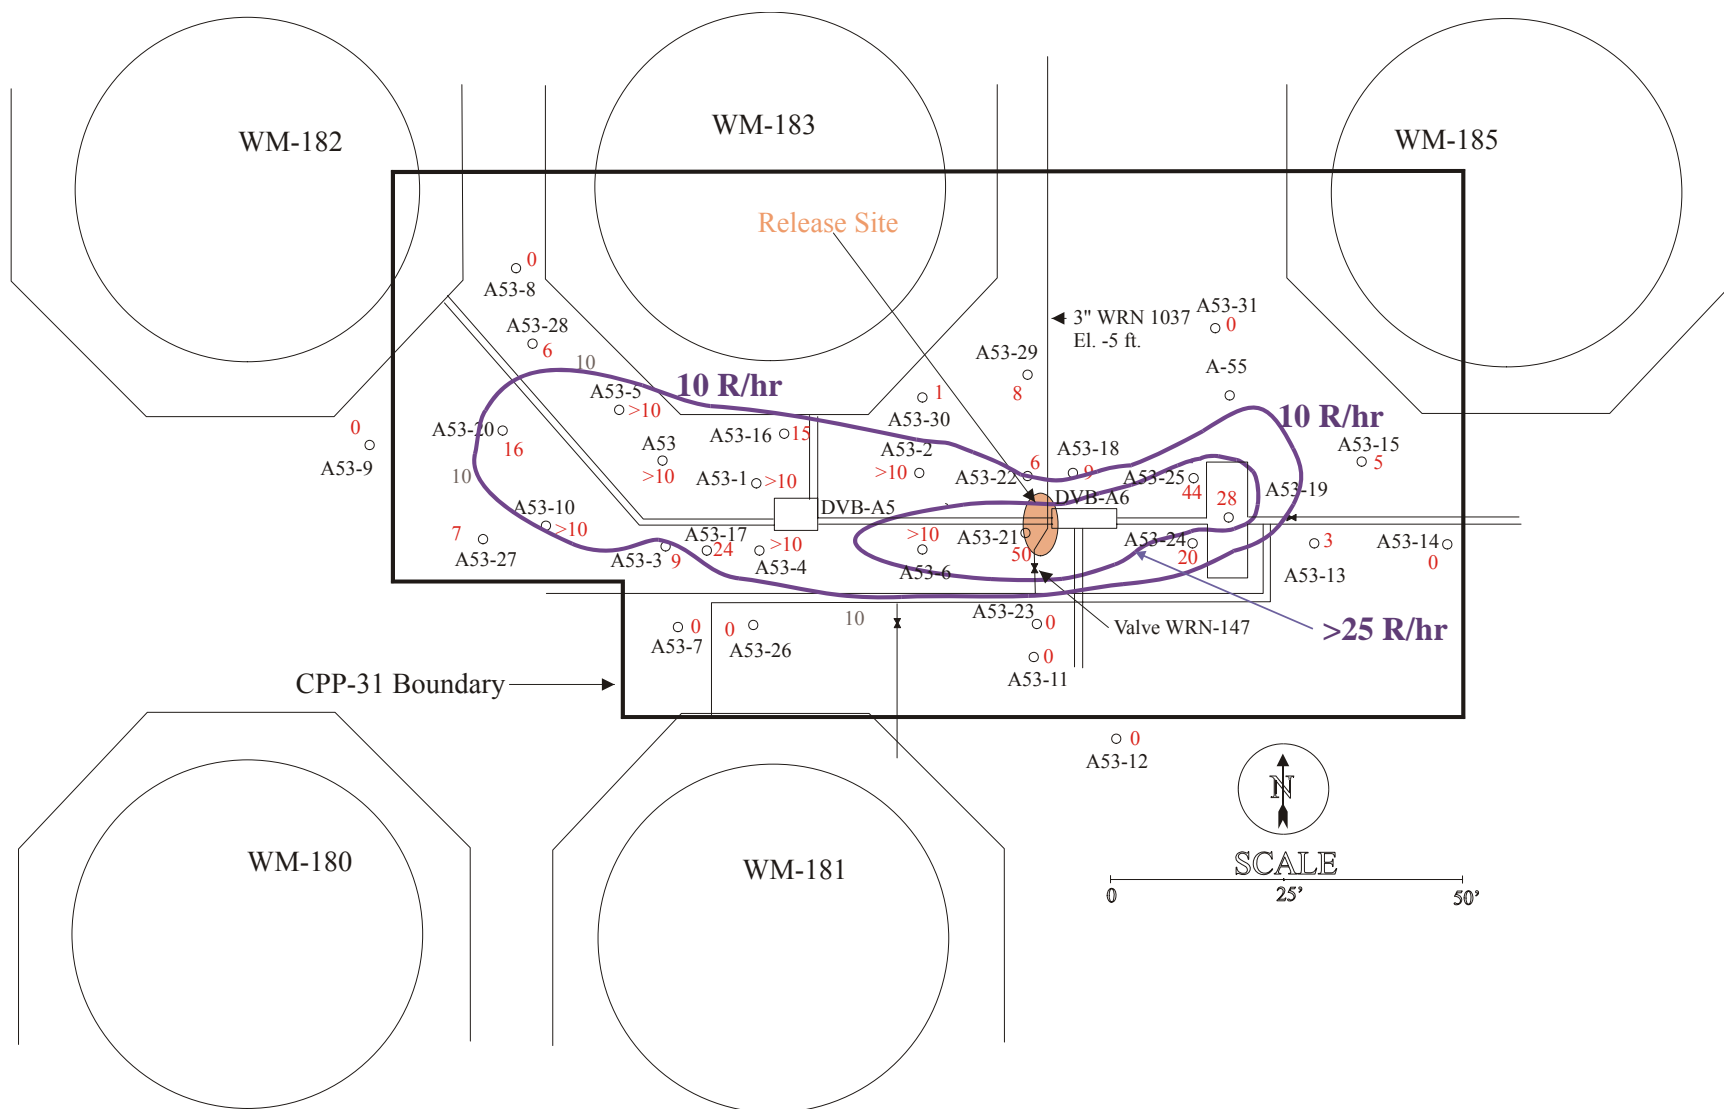
Figure 5-29. Extent of lateral contamination at the CPP-31 release site (measurements from 1975 in R/hr).

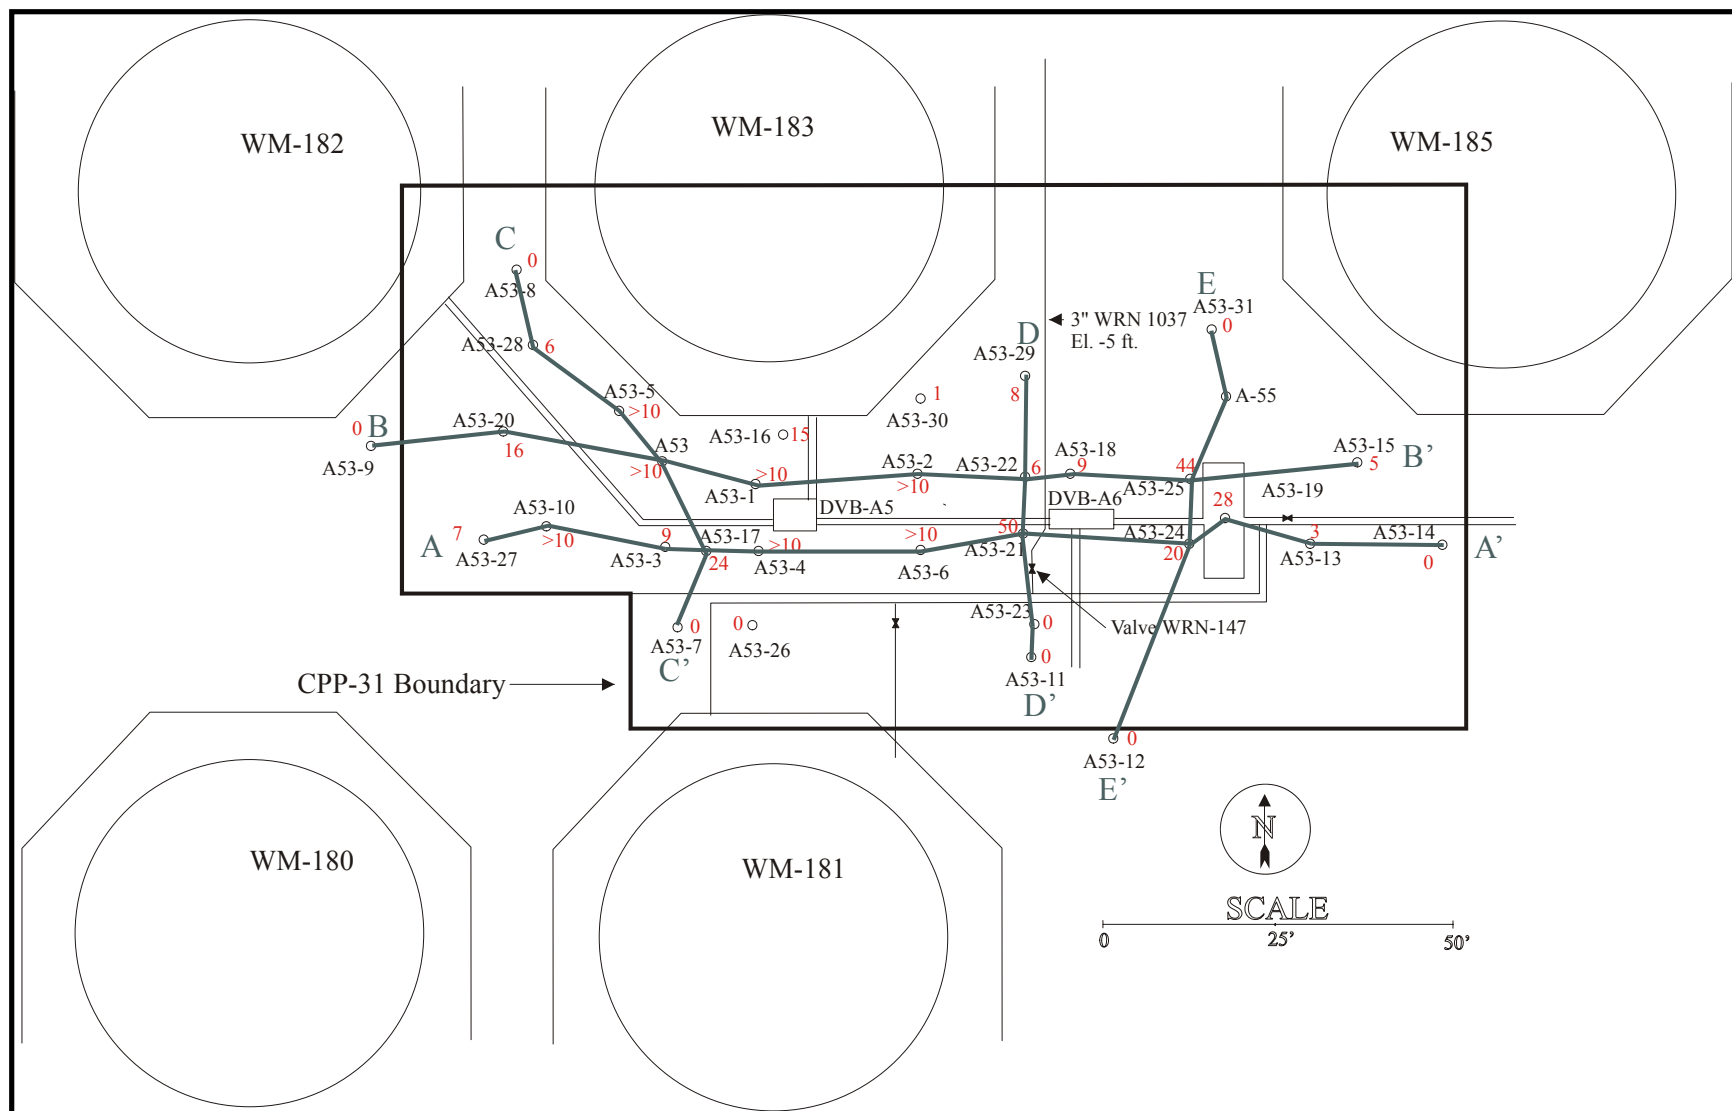
Figure 5-30. Map showing lateral extent of soil contamination (measurements from 1975 in R/hr) at CPP-31 and locations of fence diagrams.

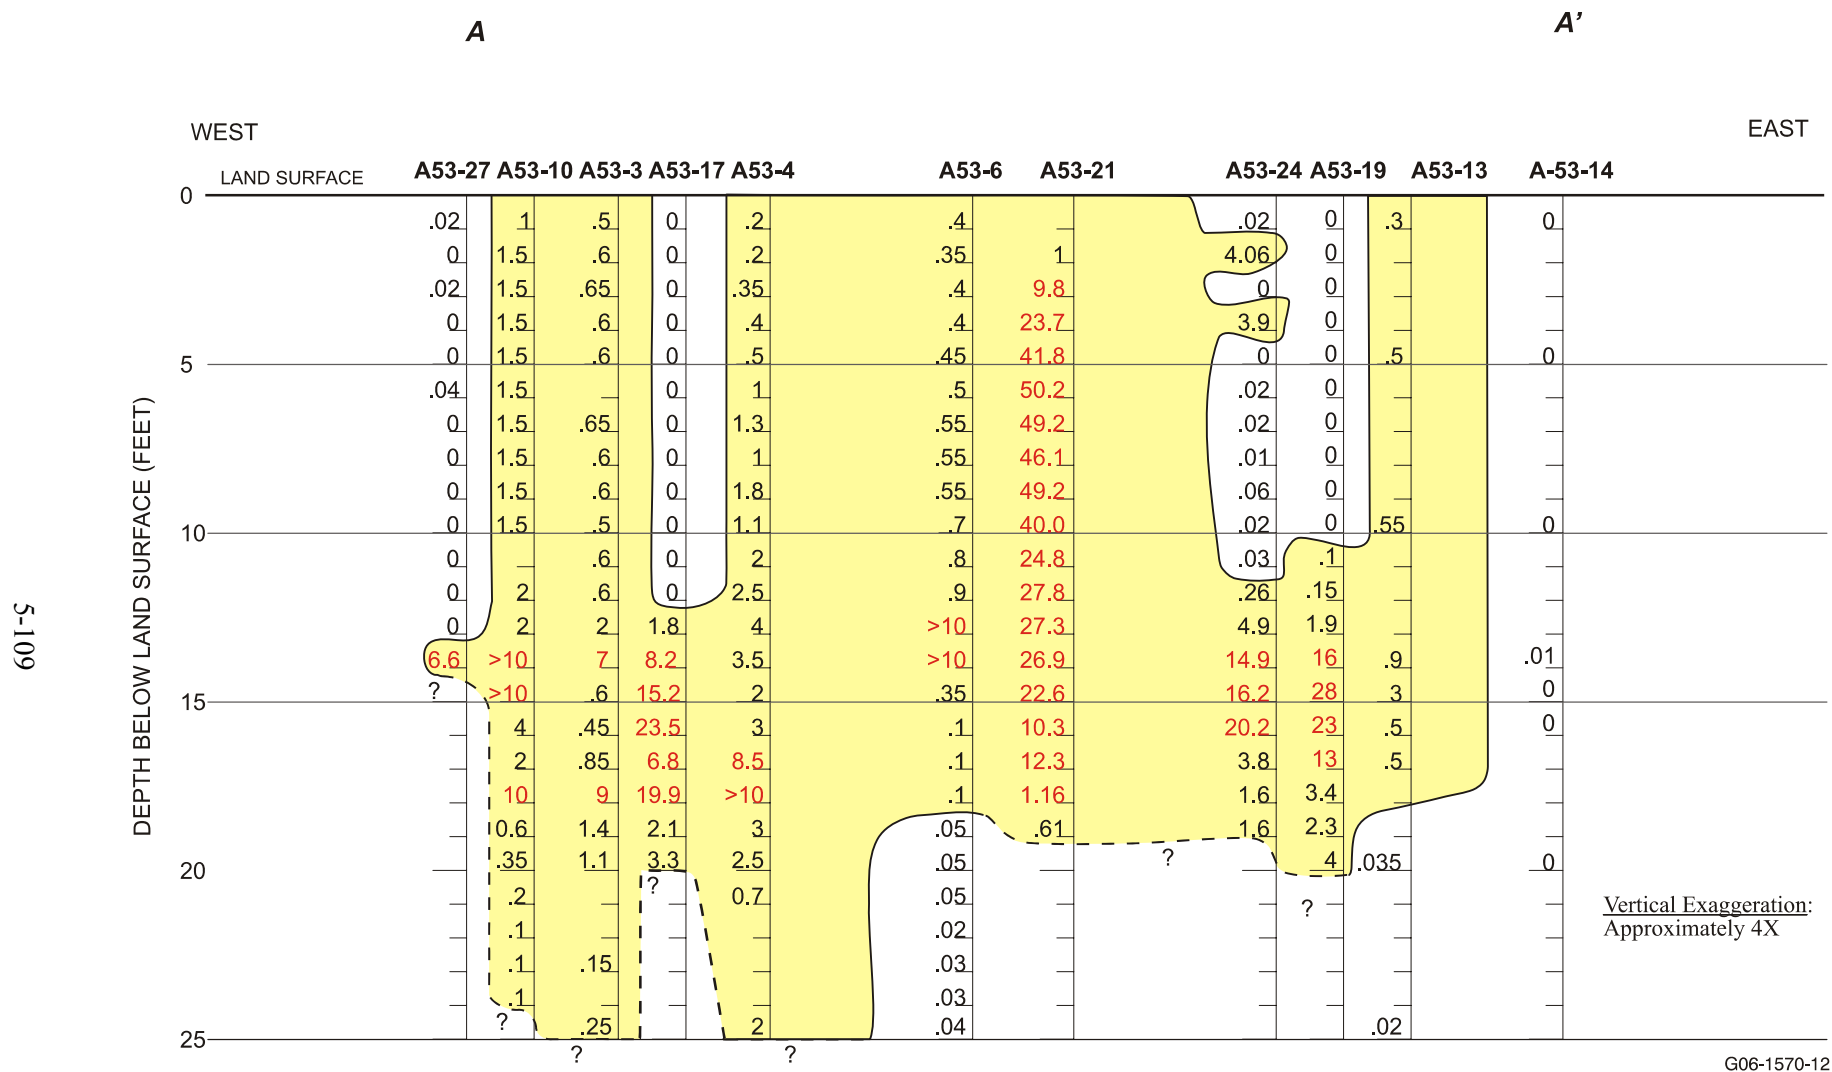
Figure 5-31. East-to-west, A-to-A', fence diagram through the CPP-31 zone of contamination (1975 radiation readings are in R/hr; readings >5 R/hr are shown in red). Zone of contamination is defined as  $\geq 0.1$  R/hr. Blanks indicate no reading was taken at that depth, but the estimated zone of contamination includes these if a deeper reading was greater than 0.1 R/hr. A 0 value indicates the reading was at background level or less than 0.01.

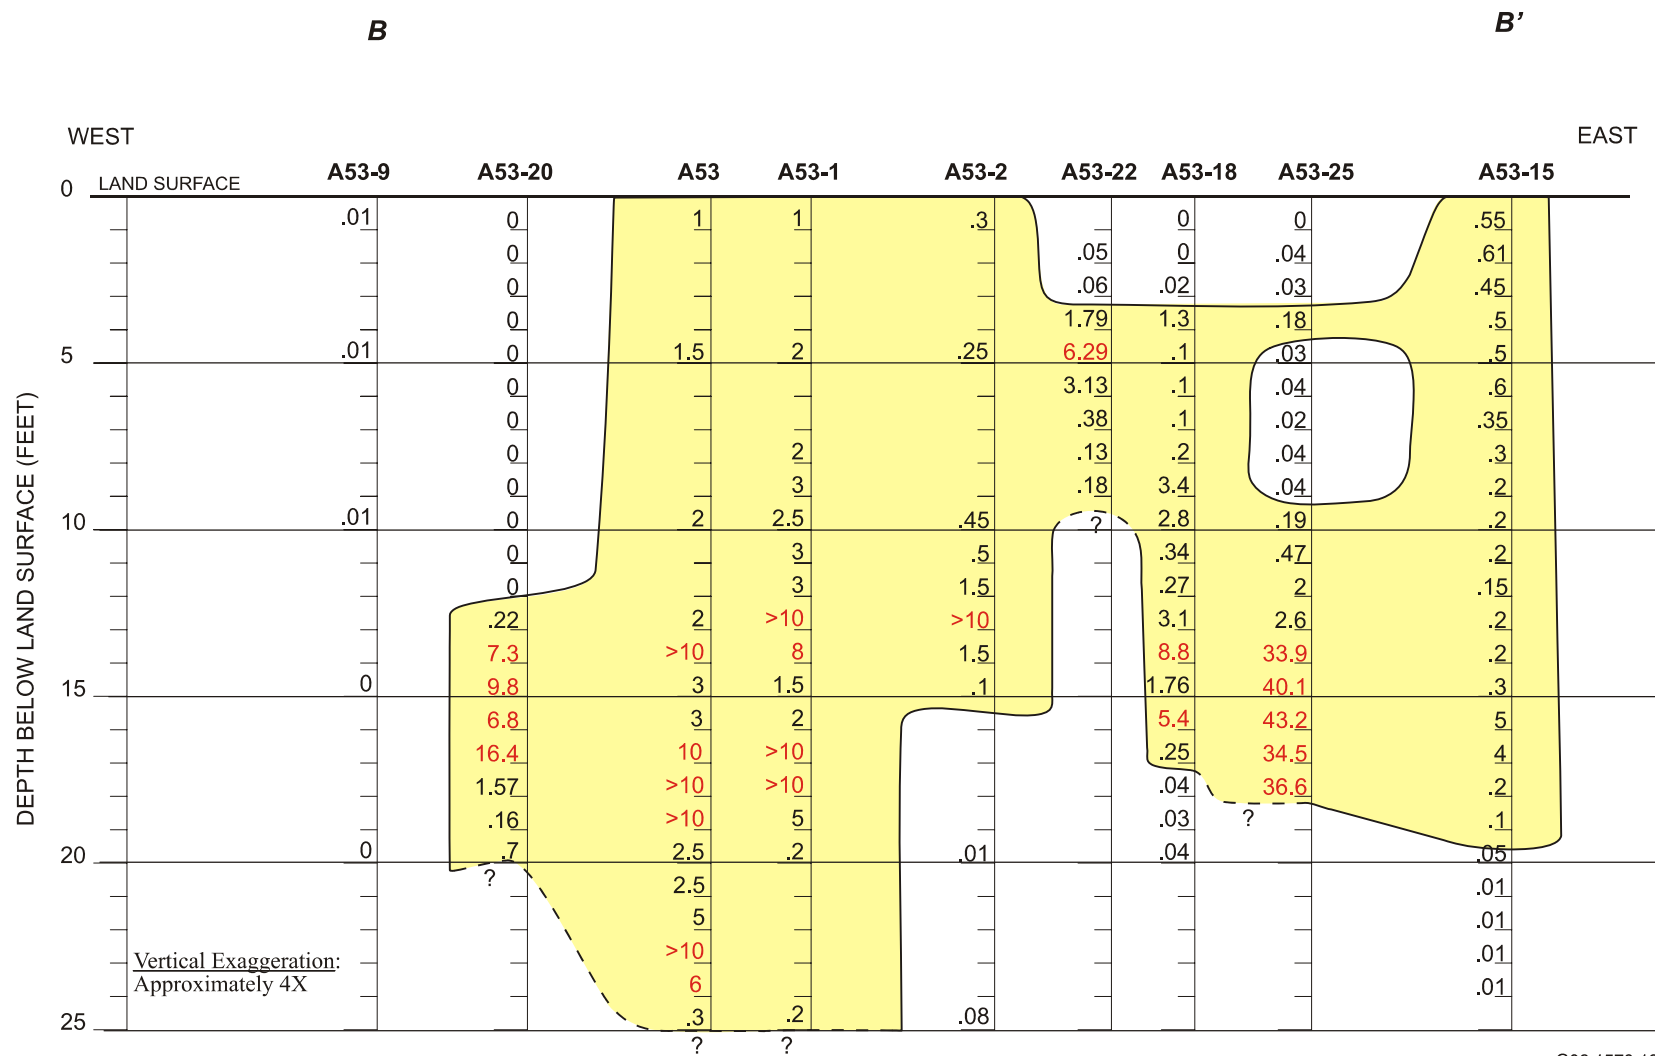
Figure 5-32. West-to-east, B-to-B', fence diagram through the CPP-31 zone of contamination (1975 radiation readings are in R/hr; readings >5 R/hr are shown in red). Zone of contamination is defined as  $\geq 0.1$  R/hr. Blanks indicate no reading was taken at that depth, but the estimated zone of contamination includes these if a deeper reading was greater than 0.1 R/hr. A 0 value indicates the reading was at background level or less than 0.01.

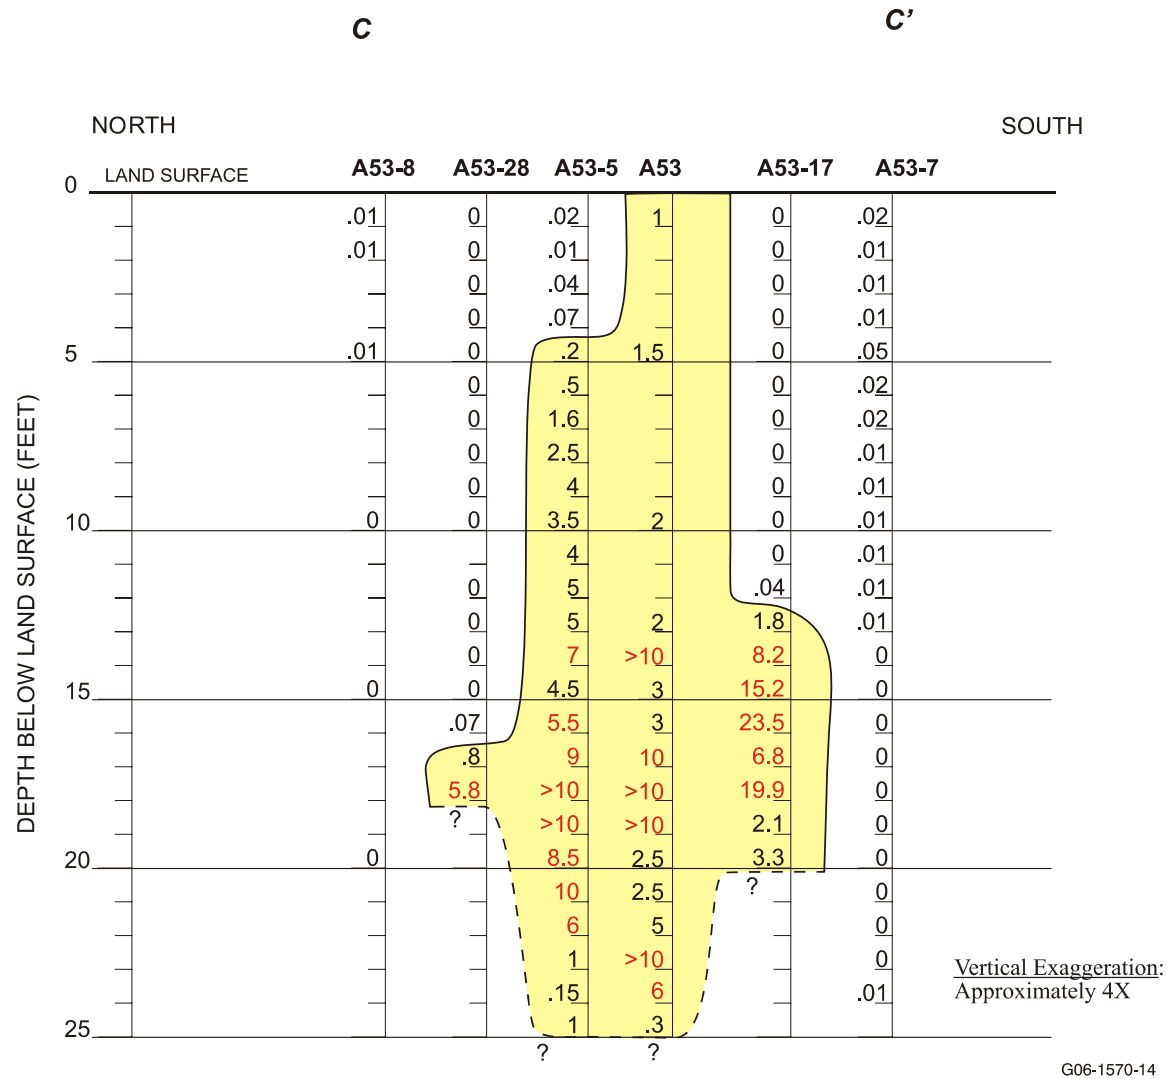
Figure 5-33. North-to-south, C-to-C', fence diagram through the body of contaminated soil at CPP-31 (1975 radiation readings are in R/hr; readings >5 R/hr are shown in red). Zone of contamination is defined as  $\geq 0.1$  R/hr. Blanks indicate no reading was taken at that depth, but the estimated zone of contamination includes these if a deeper reading was greater than 0.1 R/hr. A 0 value indicates the reading was at background level or less than 0.01.

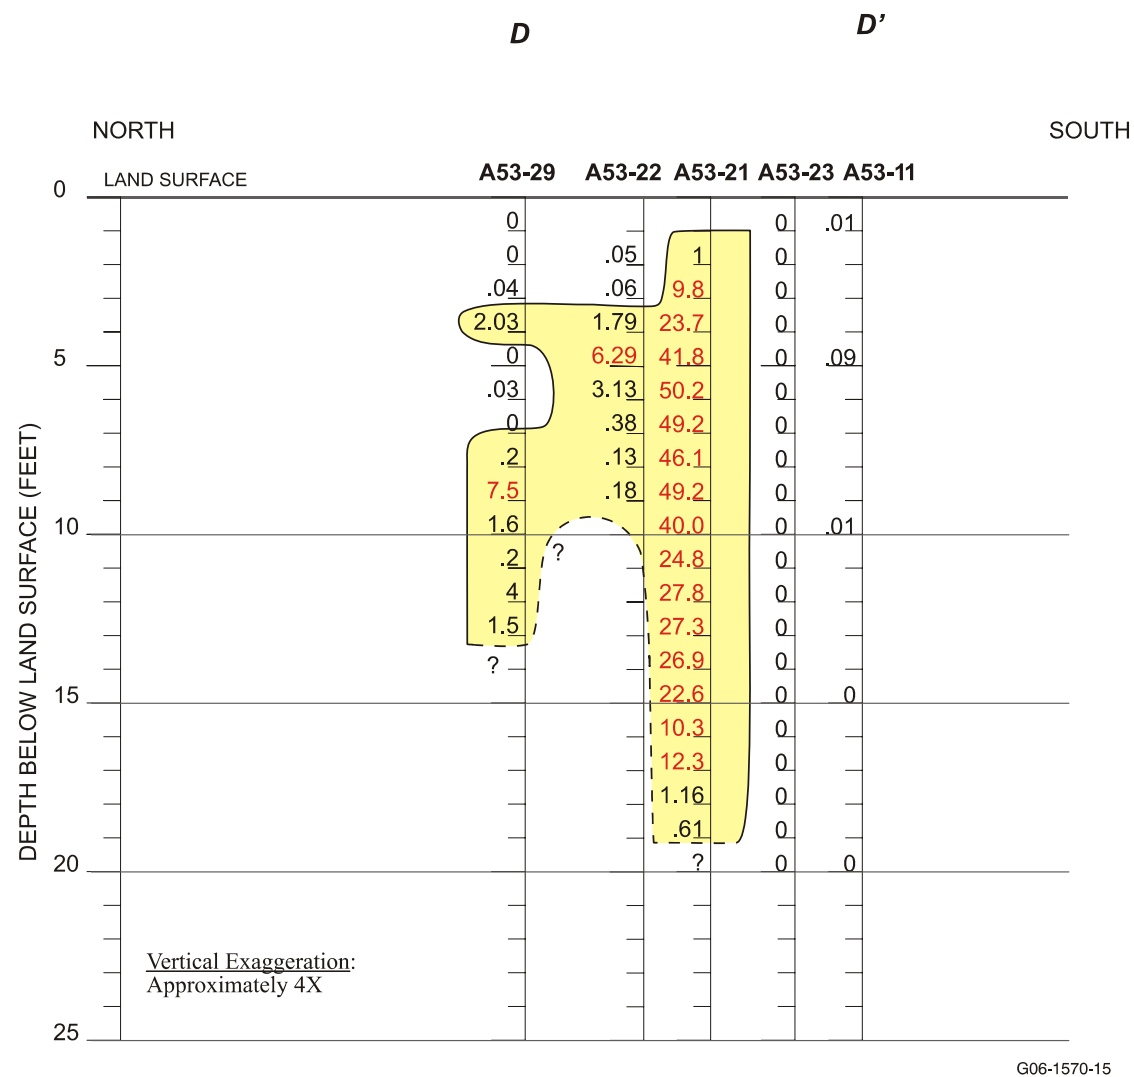
Figure 5-34. North-to-south, D-to-D', fence diagram through the body of contaminated soil at CPP-31 (1975 radiation readings are in R/hr; readings >5 R/hr are shown in red). Zone of contamination is defined as  $\geq 0.1$  R/hr. Blanks indicate no reading was taken at that depth, but the estimated zone of contamination includes these if a deeper reading was greater than 0.1 R/hr. A 0 value indicates the reading was at background level or less than 0.01.

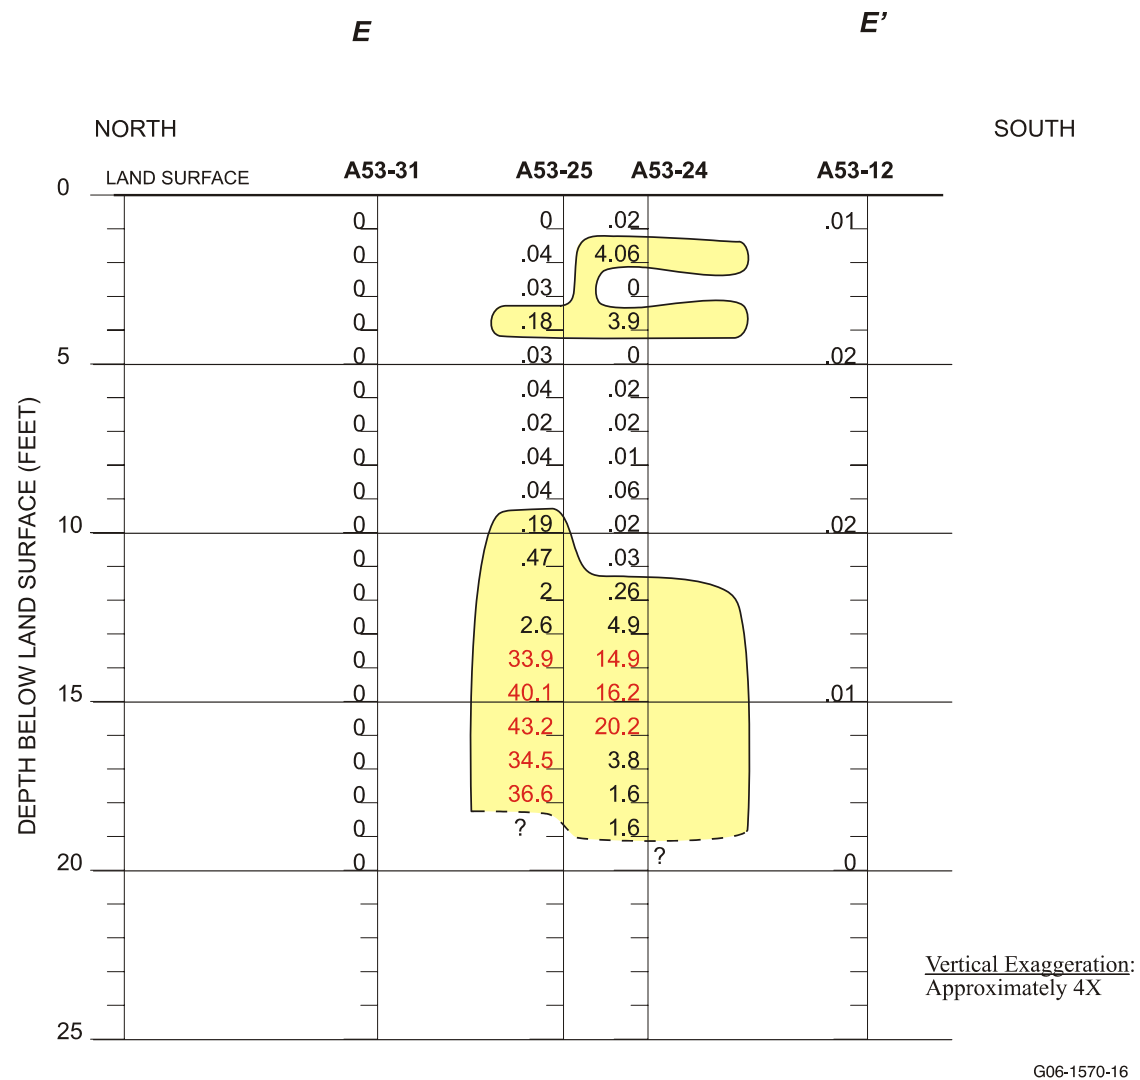
Figure 5-35. North-to-south, E-to-E', fence diagram through the body of contaminated soil at CPP-31 (1975 radiation readings are in R/hr; readings >5 R/hr are shown in red). Zone of contamination is defined as  $\geq 0.1$  R/hr. Blanks indicate no reading was taken at that depth, but the estimated zone of contamination includes these if a deeper reading was greater than 0.1 R/hr. A 0 value indicates the reading was at background level or less than 0.01.
